# Geo-environmental Assessment

Vistry Group

Nottingham City Airport, Tollerton.

Ref: PJSG21-55-RT-02

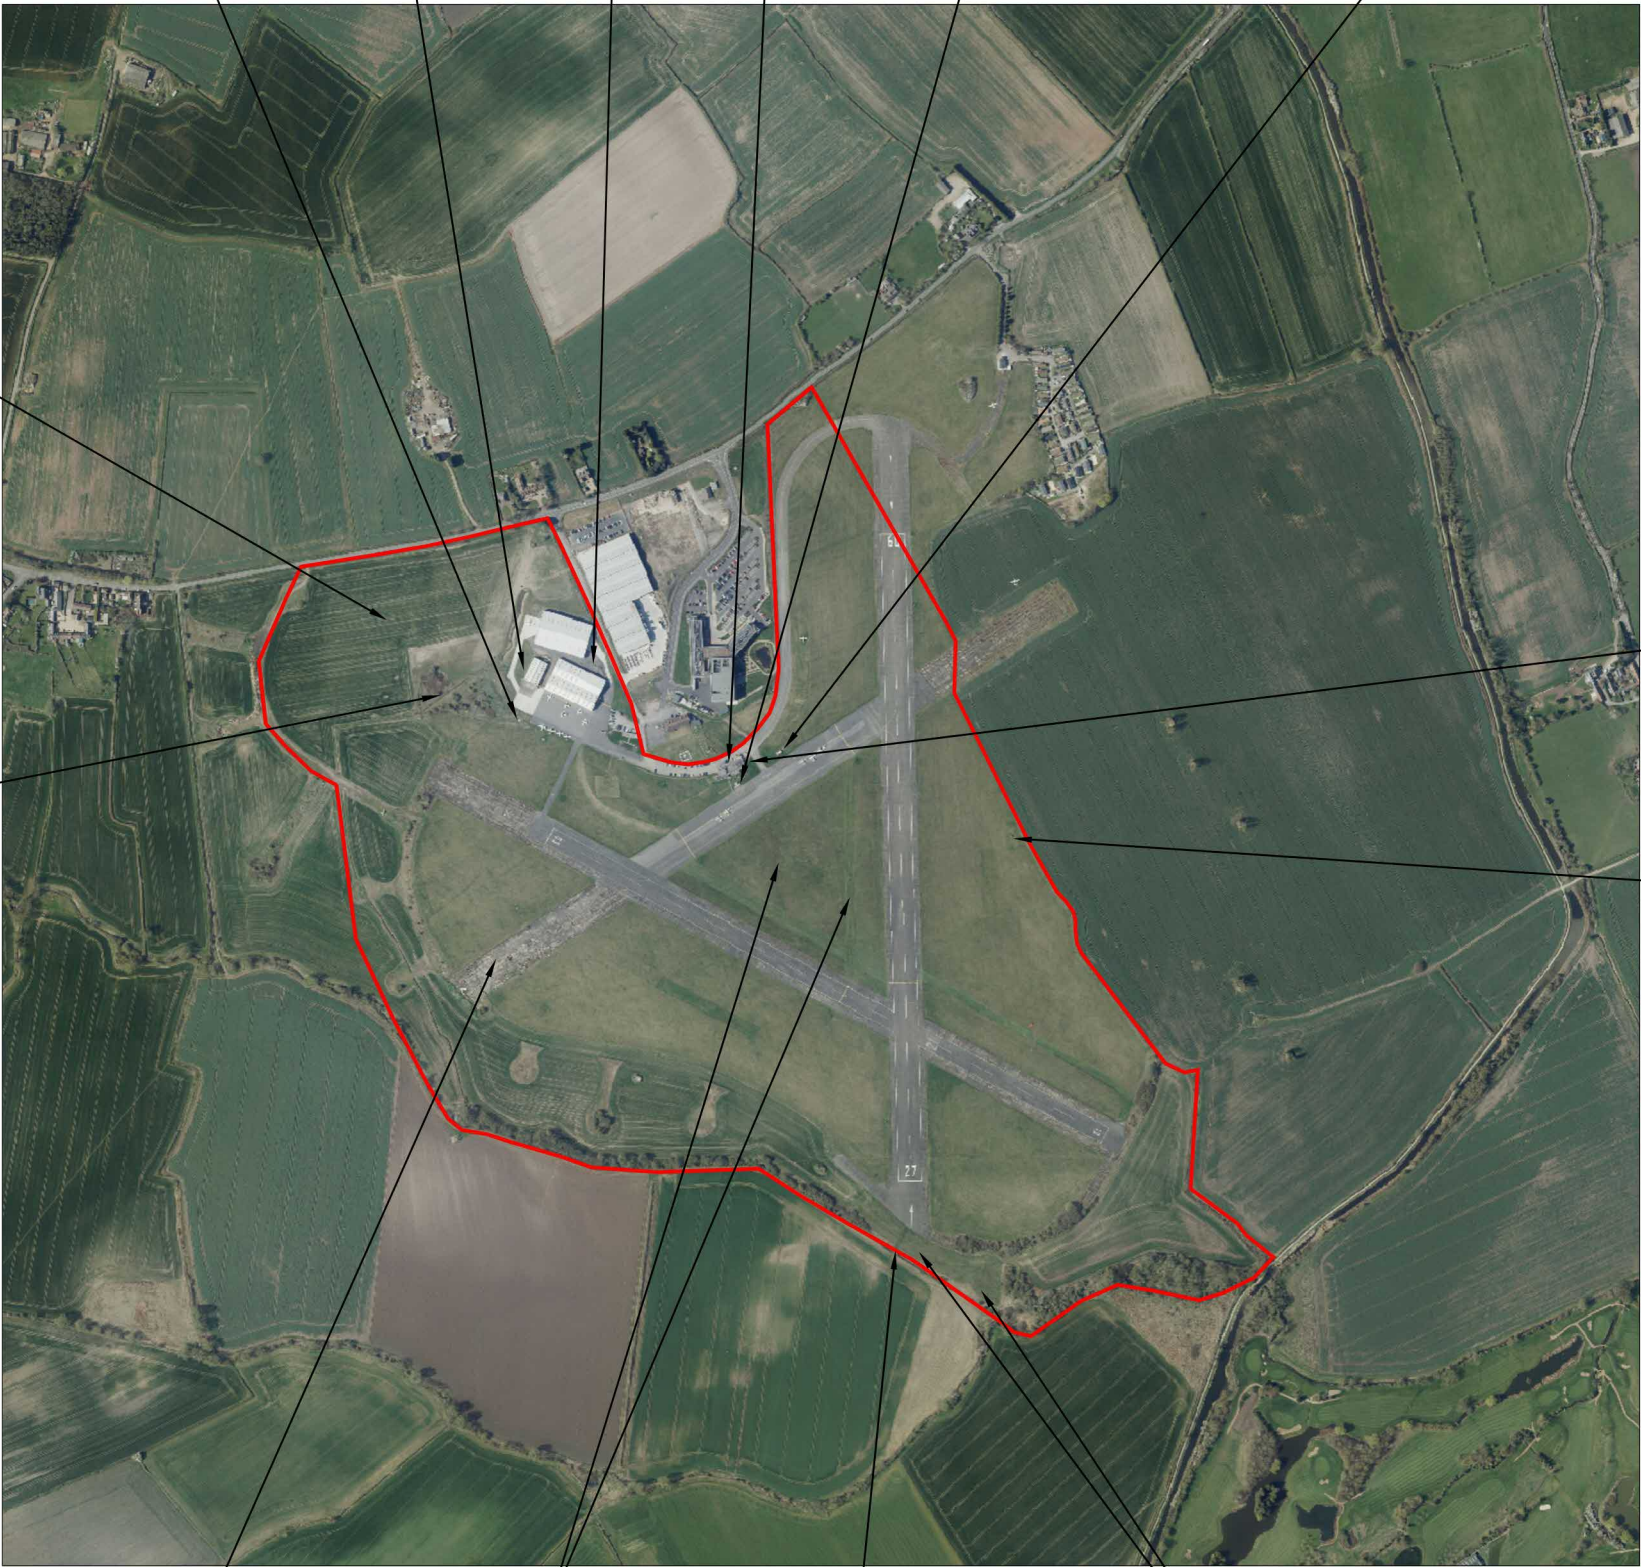
**Photograph 4**  
Heating oil system

**Photograph 5**  
Shed which previously contained an electric transformer
